The Village at Franklin Park Association, Inc.

EXHIBIT 1

**RE: Village at Franklin Park, St. Albans, VT**

**RE: Assurance of Discontinuance Comments  
GSD Enterprises, Inc. – GSD Development, LLC  
Village at Franklin Park, St. Albans, Vermont**

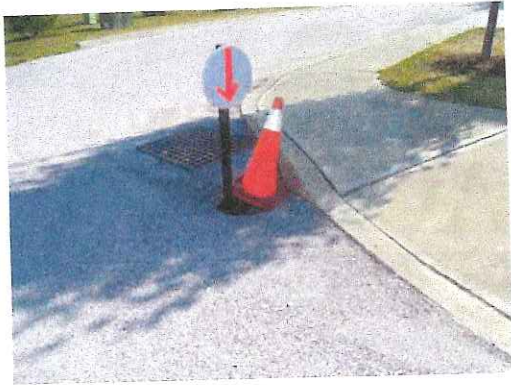
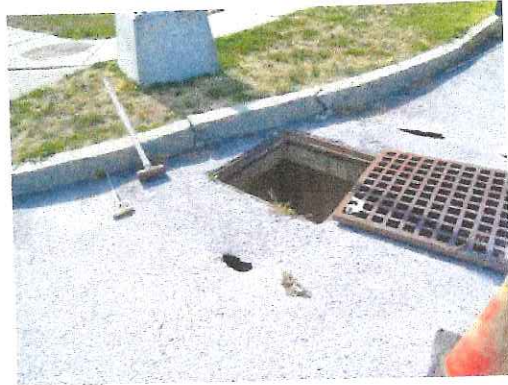
- On the day of my site visit, August 20<sup>th</sup>, settlement around two catch basins had resulted in holes in the asphalt. Several others showed significant depressions around the catch basin structure that may over time result in holes and others showed slight depressions. Holes in the asphalt are obviously hazardous, but even

the slight depressions can result in dangerous icing during the winter months. These issues are particularly concerning in an elderly housing development.

- Any catch basin showing evidence of adjacent settlement should be reconstructed to the original specifications. This would include removal and resetting of the catch basin structure, as well as removal and replacement or adjacent piping, paving, curbing and sidewalks. If left in place, this settlement will likely continue over time resulting in further failures.

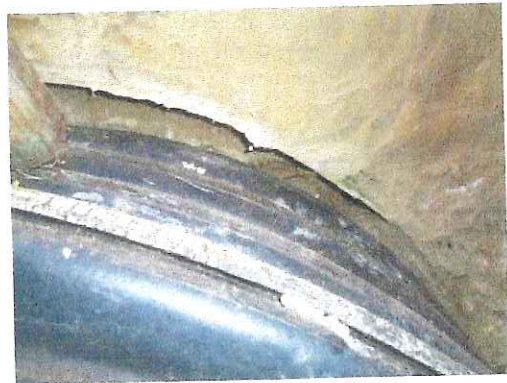
- The storm pipes have settled and deformed near at least one of the catch basins. This may result in pipe failure over time.
- Some pipe penetrations into the catch basins have settled and gaps have formed between the pipes and the grout. This may result in washing of fine materials around the structure and eventually undermining of the pipe and roadway.

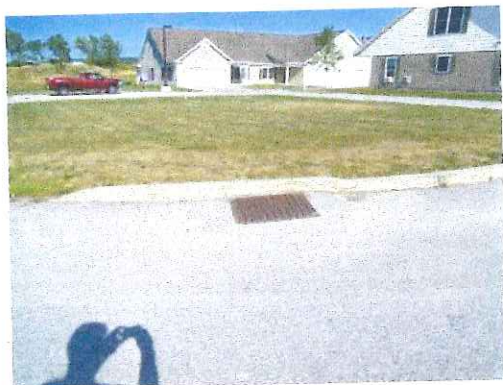
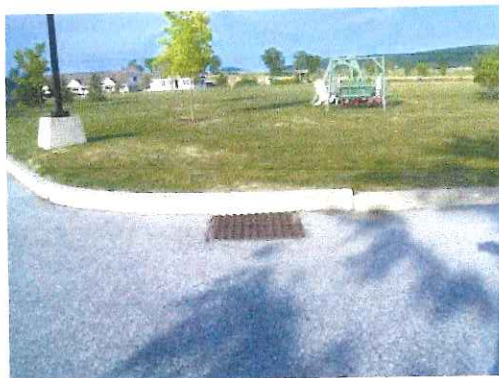
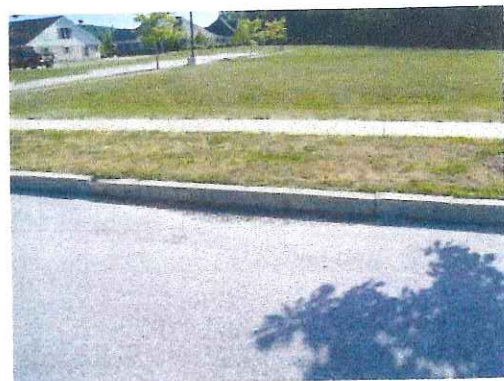
- In several areas, particularly around the catch basin structures, curbs have settled resulting in uneven curb elevations and cracking of the curbs.

- Uneven and cracked curbs and sidewalks should be removed and reconstructed in accordance with the original specifications.
- The sidewalk adjacent to Garden Circle should be removed and reconstructed with a grass strip between the new sidewalk and roadway curb as shown on the original plans.

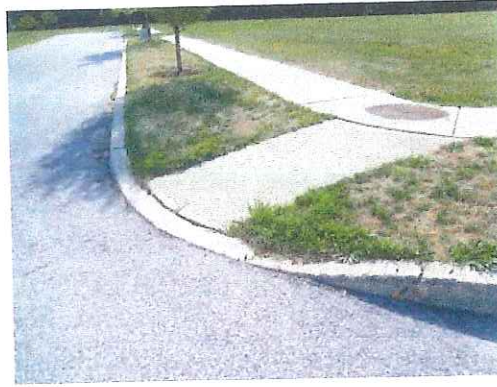
to be greater than the maximum allowable of ¼” or ½” (depending on beveling). Also, the sidewalks are cracked in several places. This would not be expected in a new development and may be related to the compaction issue discussed above.

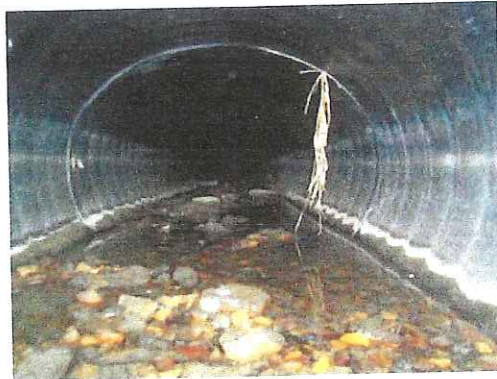
During my site visit I also noted an unusual amount of sediment buildup in the 3-foot sumps of the catch basins and within the stormwater piping. Some of the sediment included relatively large rocks that could not have entered the system through the stormwater grates.

- Sediment accumulated in the catch basin sumps and stormwater piping should be removed.
- Catch basin inlet protection should be added to all inlets that may receive runoff from disturbed areas.

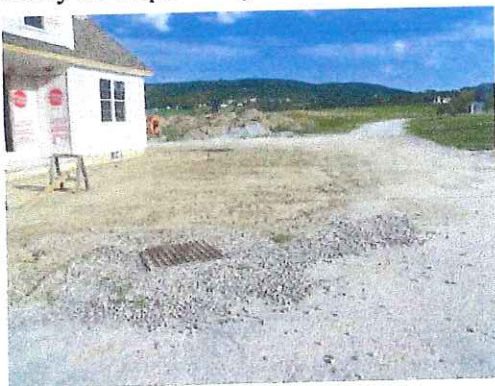
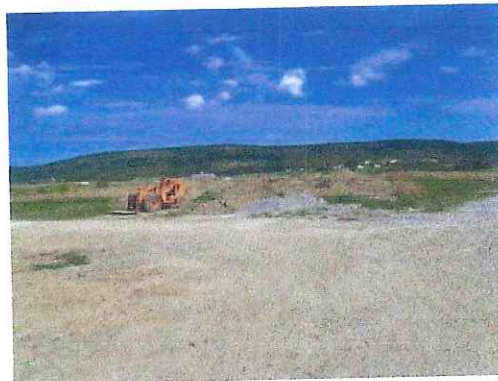
While I realize that a majority of the site is currently stabilized with grass regrowth, I witnessed no effort to limit further sediment runoff from areas where the soil was disturbed. There was no evidence of catch basin inlet protection as specified in Detail 2 on Sheet S-22. The stockpiled materials were not protected with a perimeter silt fence, and the stockpile had not been mulched as would likely be required by the Construction General Permit.

- Disturbed areas should immediately be temporarily stabilized in accordance with wintertime construction practices and silt fence should be added to the lower limit of disturbance.

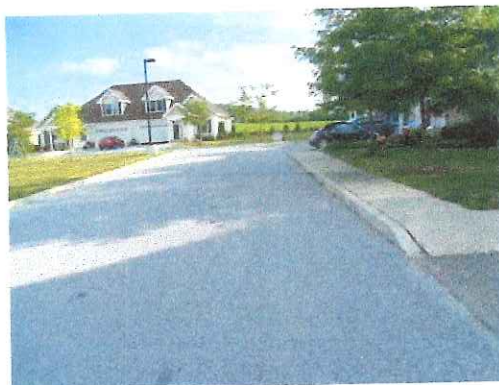
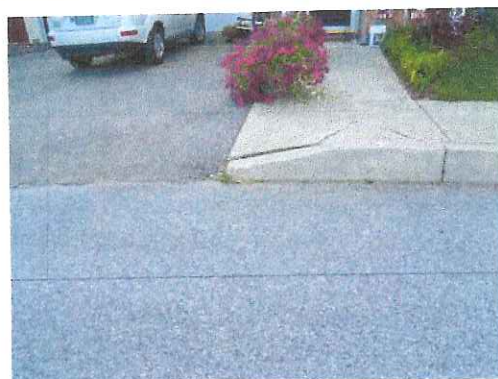
I also noted that some sidewalk handicap ramps are steeper than 1:12 specified on the approved plans and required by the Americans with Disabilities Act (ADA). Some changes in elevation along the sidewalk and at the intersections with the curb and asphalt appear

- Sidewalks and ramps not meeting ADA requirements for slope and changes in elevation should be removed and reconstructed in accordance with the original specifications.

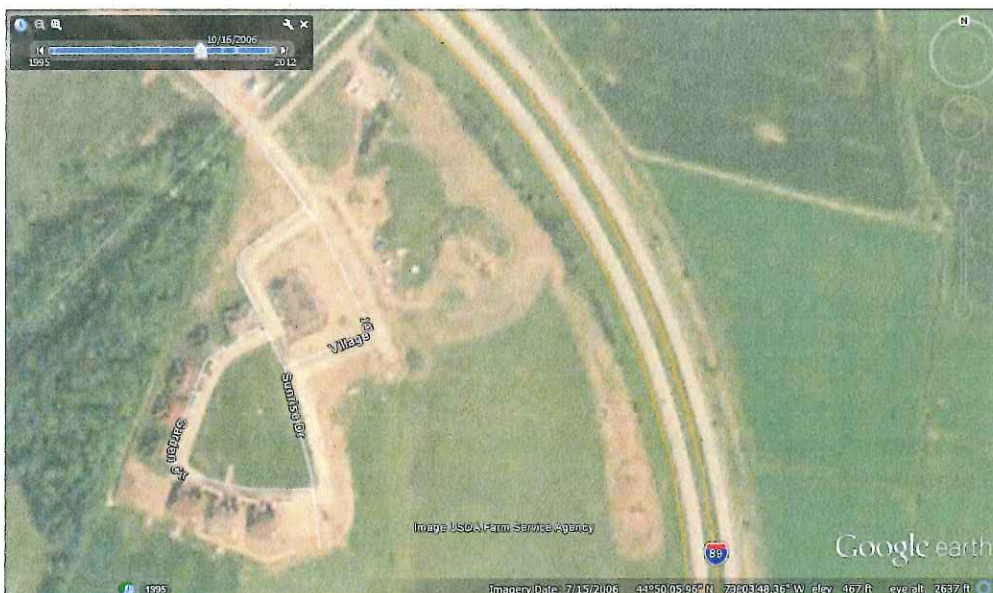
Based on my observations over the last two years, the sediment in the stormwater system is a result of absent and inadequate erosion control measures. I did not observe any inlet protection or silt fencing. Available aerial photography from July of 2006 shows a majority of Phase I and part of Phase II residences erected yet a majority of the disturbed areas have little or no vegetation.

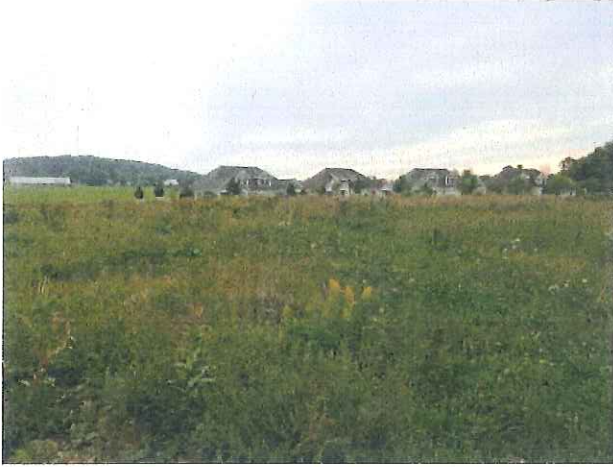
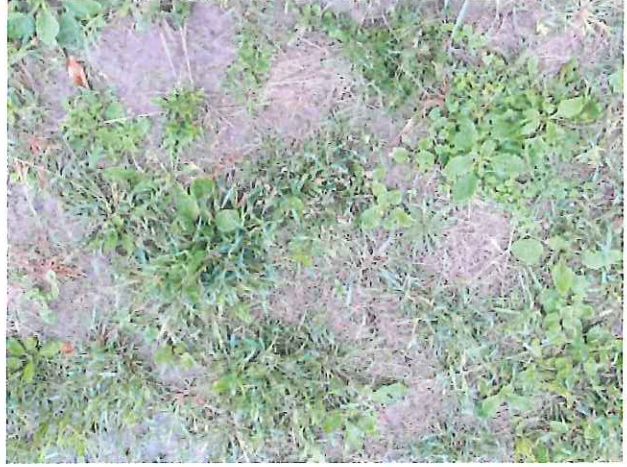
I've also included a couple photos that demonstrate your point about a lack of seeding of disturbed areas. These show typical weedy vegetation on previously disturbed areas on-site.

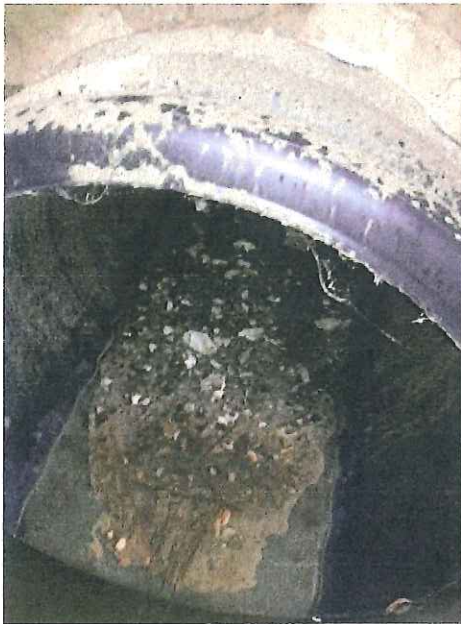
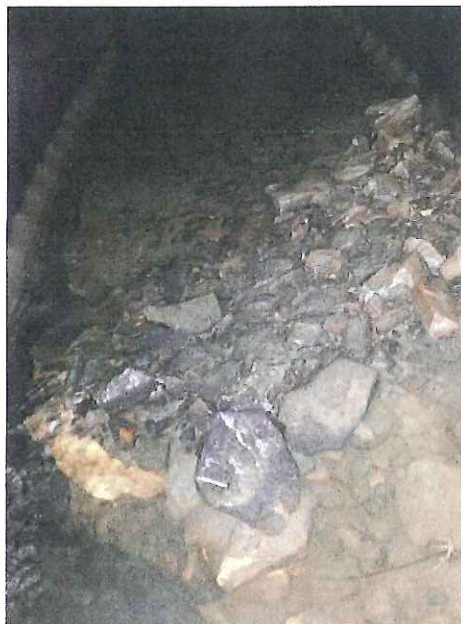
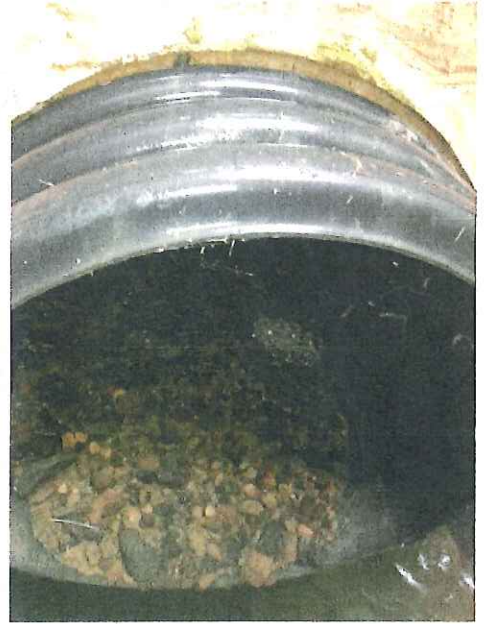
Additionally, even though some sediment has been removed from the catch basin sumps there are still several pipes containing rocks and sediment (observed in pipe segments CB 37 to CB 55, CB 37 to CB 36, CB 36 to CB 30, CB 28 to CB 29, CB 29 to CB 30, though there may be others). The photos immediately below and later in this letter illustrate this.

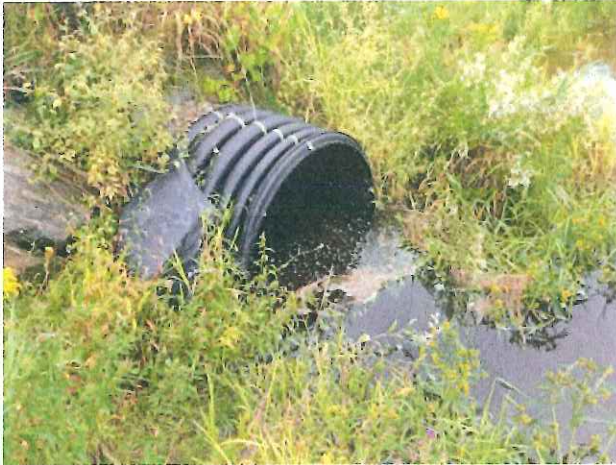
As of my most recent site visit, 9/12/13, the new end section had not been installed. (See photo below)

With regard to the end section into the forebay, it is my opinion that an HDPE end section may have an advantage in corrosion resistance, but a metal end section is tougher and more resilient. Either may be acceptable for this application, but both require proper installation to function properly. When the damaged end section and accumulated sediment were removed, it appears the Type III stone fill riprap may have also been removed. This should be replaced immediately to limit potential erosion at the pipe outfall.

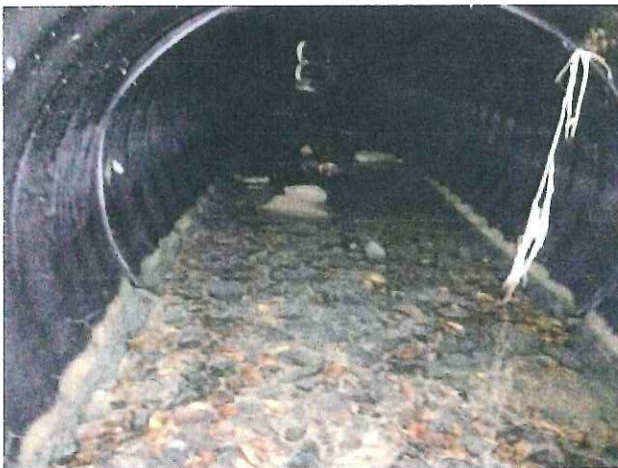
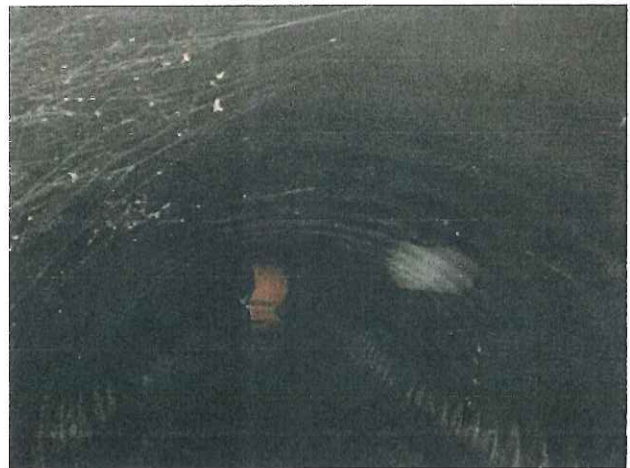
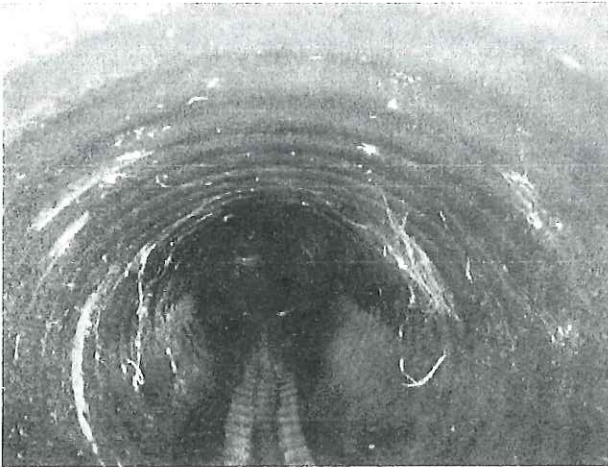
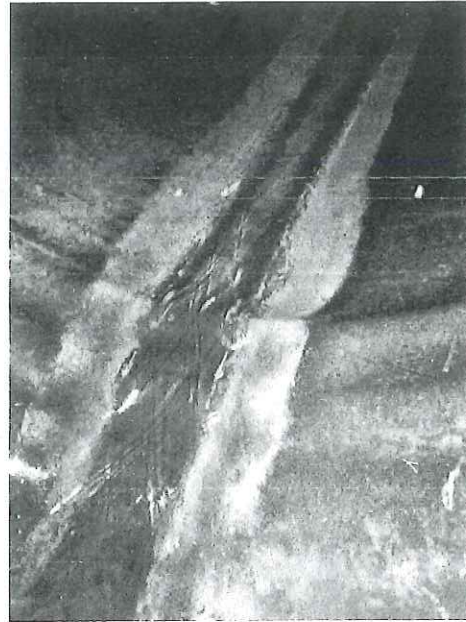
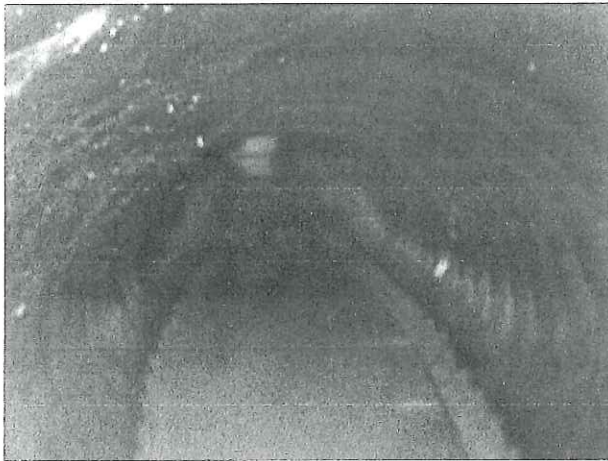
One of the major construction issues within this development is the problem of settlement of the areas adjacent to catch basins. The main reason for this is a lack of adequate compaction of material around catch basins and under drainage pipes. This has resulted in the creation of depressions and sinkholes at numerous catch basins. The developer has attempted to patch the asphalt in these areas, but this is a temporary fix that only masks the underlying problem. Beneath the surface several pipes are beginning to fail just outside the catch basins (CB 37 and CB 41 are particularly bad and worse than I observed just two years ago). There are several others that I was not able to inspect due to their depth below grade.

On inspection it is obvious at these locations that the material beneath the pipes immediately outside the catch basin was not properly compacted. The design drawings refer to specifications for requirements regarding compaction of backfill. Cross Consulting Engineers, P.C. supplied us with specifications for Trenching (Section 02225), Site Water Lines (Section 02667) and Site Sanitary Sewerage Systems (Section 02732), but according to Mr. Garceau they were unable to locate the specification for the Site Storm Sewerage and Underdrain Systems (Section 02722). The specification for Trenching calls for "compaction to 95% Modified Proctor density" "under structural areas and within 36" of structural areas." I've included a copy of these specifications. I've also included Advanced Drainage Systems (ADS) Technical Note 5.04 regarding *HDPE Connections to Manholes and Structures*. ADS is believed to be the manufacturer of the HDPE piping utilized on this project. Their details also specifically state "Performance highly dependent on installation. Contractor must insure manhole gasket is uniformly seated around structure adapter. Extra precautions must be taken to prevent differential settlement between pipe and manhole." If the piping and catch basins had been installed with proper compaction in accordance with the design drawings, specifications and manufacturer specifications the HDPE pipes would not be failing.

Many of the existing on-site connections are not properly constructed. The cracks discussed above allow sediment to wash from around the sides of the pipes and catch basins resulting in void spaces and further sinkholes. Booted connections are far superior to grouted connections due to their flexibility, resiliency and minimal maintenance requirements. I assume this is why Cross Consulting included them in the approved design. I recommend that all deformed pipes be replaced and all catch basins with

inadequate connections be properly reconstructed or replaced with catch basins that contain the specified neoprene boot connections.

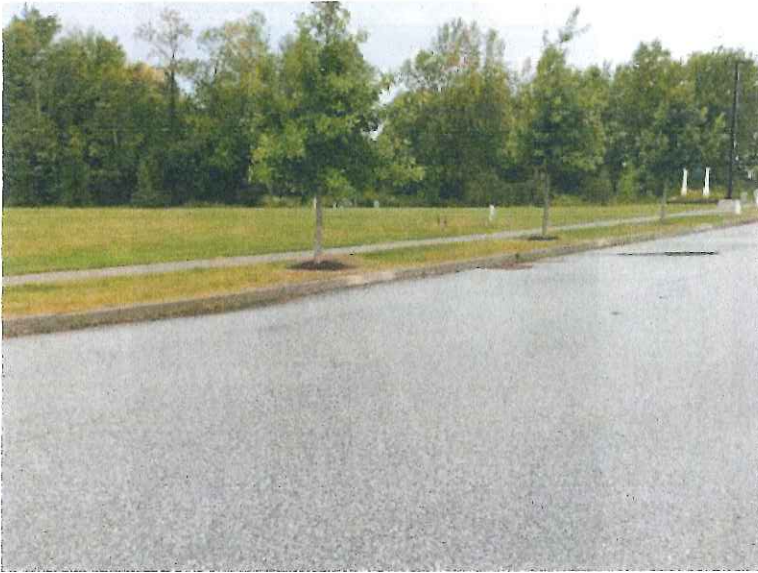
Additionally settlement was observed along the pipes to and from CB 55.

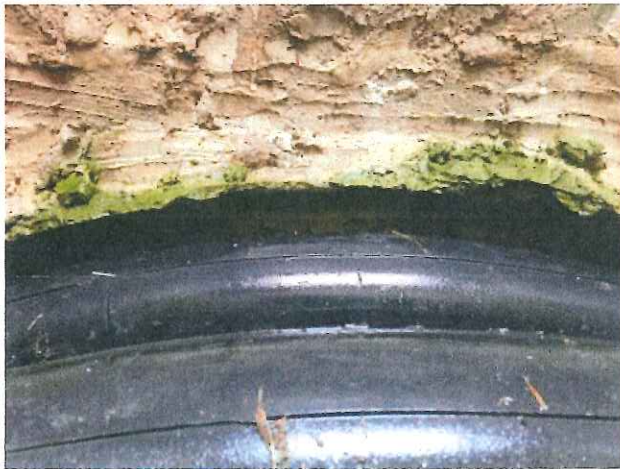
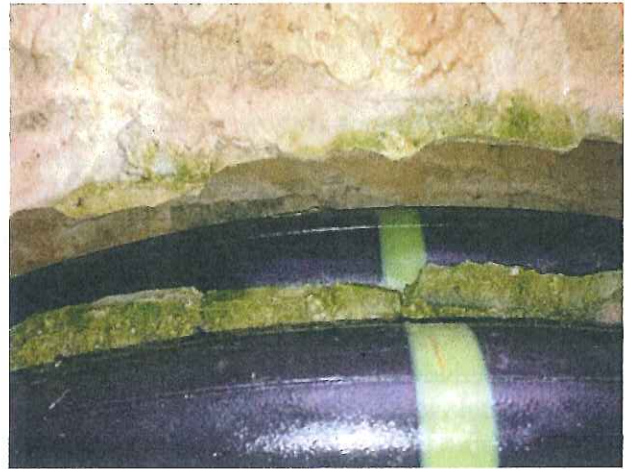
Another issue with the catch basins is the seal around the pipe penetrations. Based on my field inspections the joints sealed with neoprene boots appear to be performing better than the joints with brick and mortar. The booted connections allow for slight movement of the pipe without failure of the joint. The brick and mortar connections do not. Several of the brick and mortar connections show differential settlement and cracks around the pipe allowing for seepage of water and sediment.

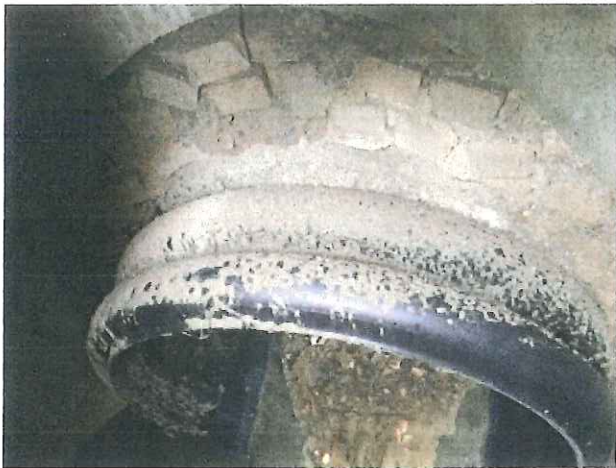
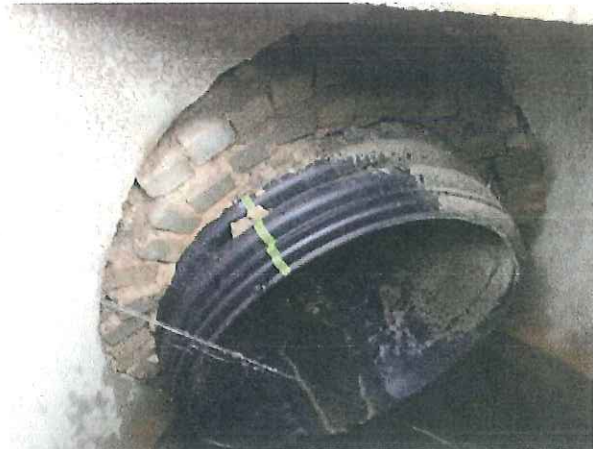
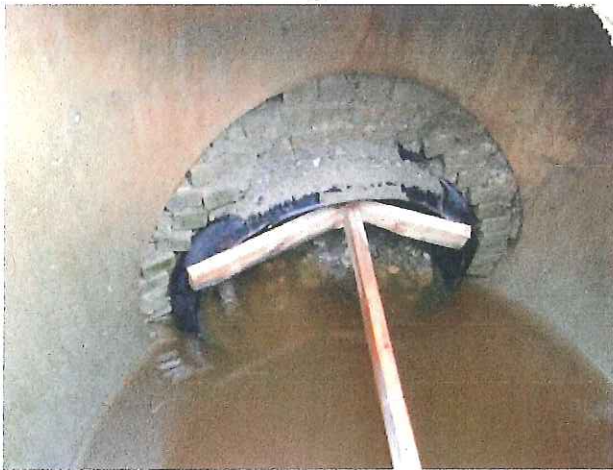
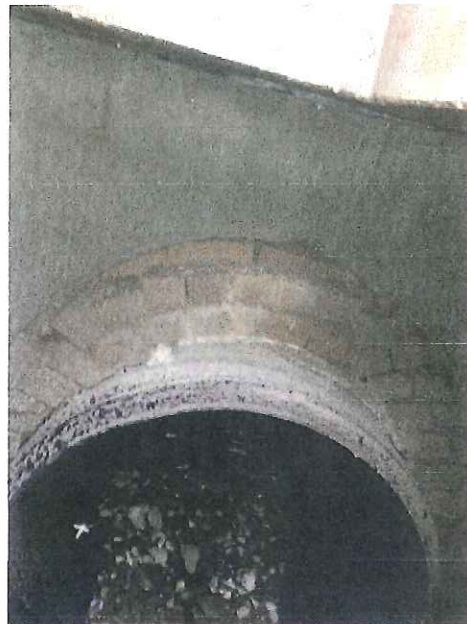
A coarse sandy material was observed entering catch basins through a few of these cracks. Some of the pipe to catch basin connections (CB 30, CB 29 and CB 28) appear to be brick with little or no mortar.

The Typical Catch Basin detail (Sheet S-19) calls for the contractor to “Install Neoprene Boot at Each Penetration”. This appears to indicate that a watertight connection is desired as opposed to a soil tight connection. Booted connections are the gold standard for HDPE penetrations of concrete catch basins. The manufacturer recommendations attached do not allow for brick or brick and mortar connections. They do allow for a non-shrink grout in soil tight applications. Several municipalities including Colchester, Vermont require booted connections for all storm pipes 6” and larger. I’ve included a copy of their standard detail. Some of the on-site catch basin pipe penetration holes simply appear to be of the wrong size for the pipes seated in them.
